Manhole Inspection Summary

Manhole # S41U__007MH

Insp Date: **10/9/08 10:58 AM**

Location Address: **901 e fort ave**

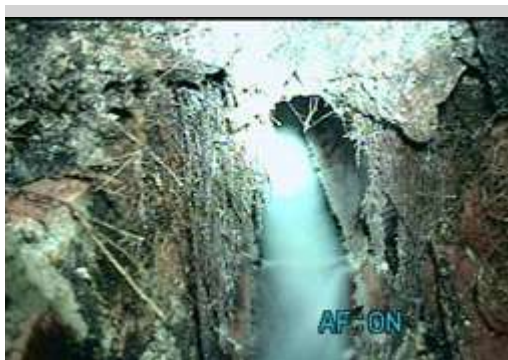
Defect 5

Condition: ☐ Sound ☐ Cracked ☒ **Root Intrusion** ☐ Deteriorated ☐ Leaks ☐ Debris

roots in channel

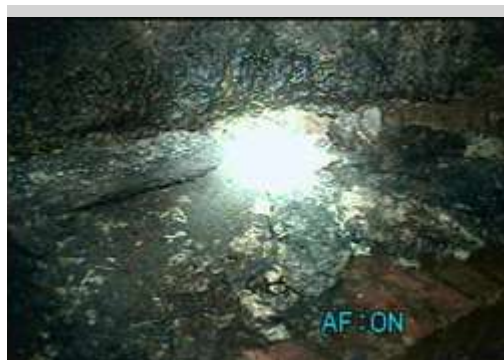
Defect 4

Infiltration: ☐ None ☐ Joint ☐ Cracks ☐ Mortar ☒ **Roots** ☒ **Wall**

Condition: ☐ Sound ☐ Cracked ☐ Root Intrusion ☐ Deteriorated ☐ Leaks ☒ **Debris**

bench debris and barrel infiltration

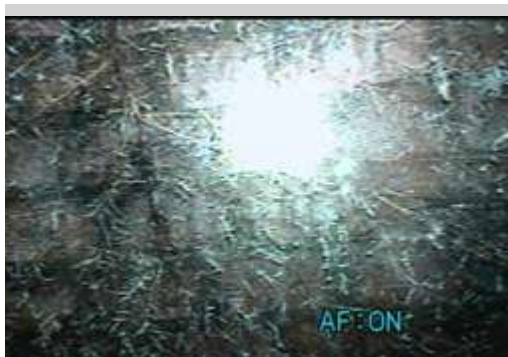
Defect 3

Condition: ☐ Sound ☐ Cracked ☒ **Root Intrusion** ☐ Loose Brick ☐ Deteriorated

roots in corbel and barrel

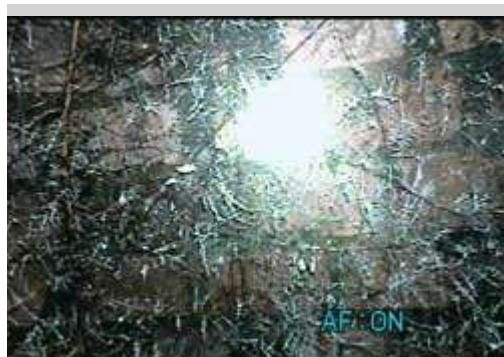
Defect 2

Condition: ☐ Sound ☐ Cracked ☒ **Root Intrusion** ☐ Loose Brick ☐ Deteriorated

roots in chimney

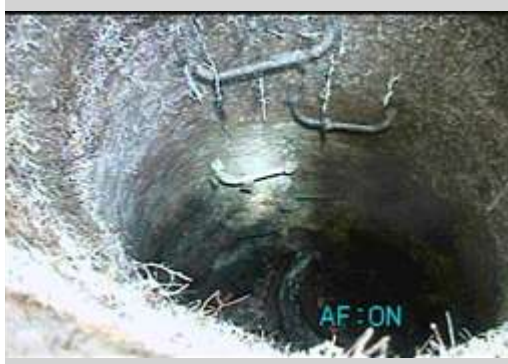
Defect 1

Count: **5** Missing: **0** ☒ **Corroded**

cor. steps
